TECHNICAL SERVICE BULLETIN

6.2L/7.3L - Illuminated MIL With DTCs P0132, P0135, P0138, P0141, P0152, P0155, P0158 And/Or P0161 - Built On Or Before 05-Jun-2020

20-2380

29 October
2020

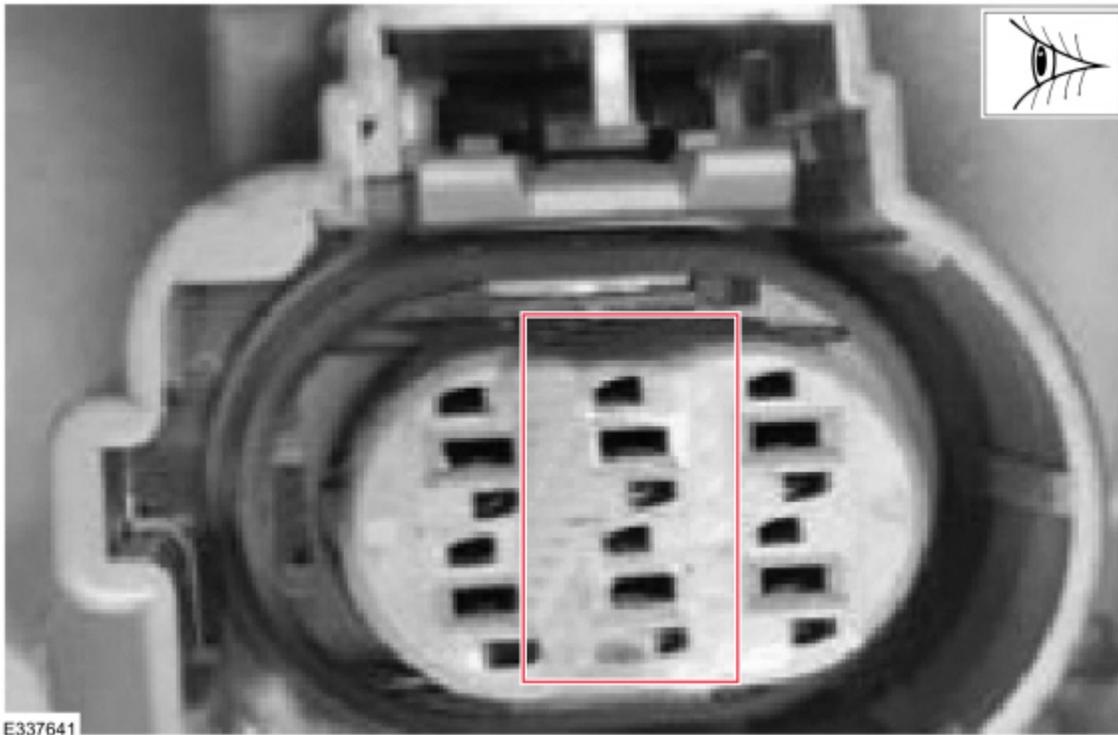
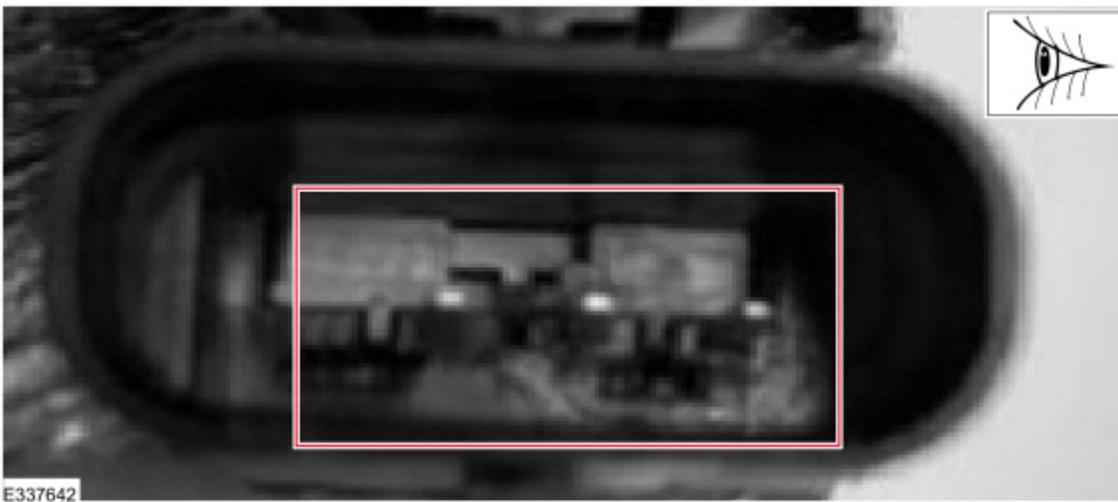
1. Disconnect the appropriate HO2S and/or the catalyst monitor sensor based on the DTC(s) received and inspect for moisture and/or corrosion on the pins of the sensor or the wiring harness. Are there any signs of moisture and/or corrosion present? (Figures 1-2)
 - (1). Yes - replace the affected HO2S and/or the catalyst monitor sensor. Refer to Workshop Manual (WSM), Section 303-14. Proceed to Step 2.
 - (2). No - this article does not apply. Refer to the Powertrain Control and Emissions Diagnosis (PC/ED) Manual for normal diagnostics.
